# Special Report 80-18

## DEICING A SATELLITE COMMUNICATION ANTENNA

B. Hanamoto, J.J. Gagnon and B. Pratt

Prepared for  
U.S. ARMY SATELLITE COMMUNICATION AGENCY

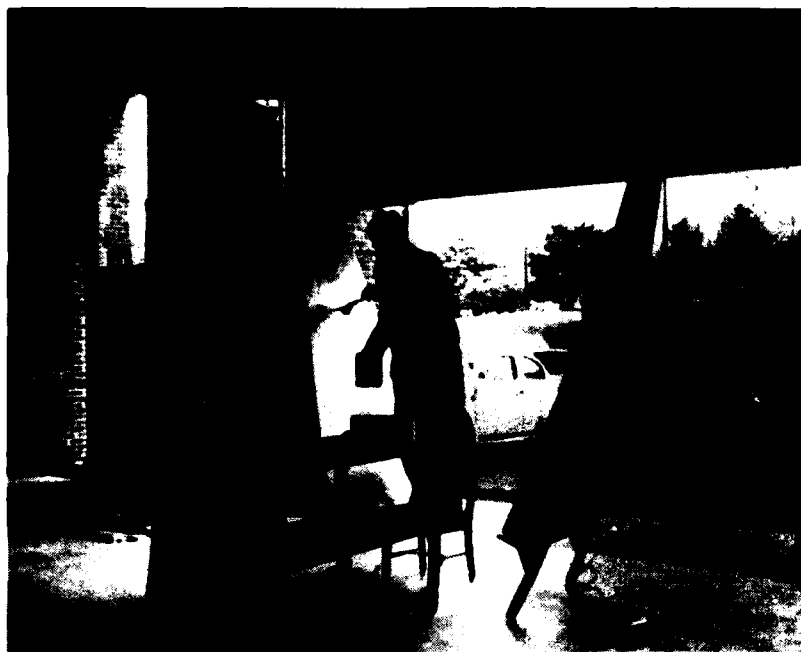
Figure 2. Copolymer application.

The panels were wiped down once more before being coated with the copolymer. Two types of the copolymer (General Electric LR5630 and GR5530) were applied to three of the panels and were designated sample A and sample B respectively. One entire panel was coated with LR5630, one with GR5530. The third panel was coated with both LR5630 and GR5530; the top half with one, the bottom half with the other. The copolymer was applied with a brush, starting at the top and making sure that the brush strokes were with the length of the panel (Fig. 2). The third panel was used for radio wave analysis of the copolymer.

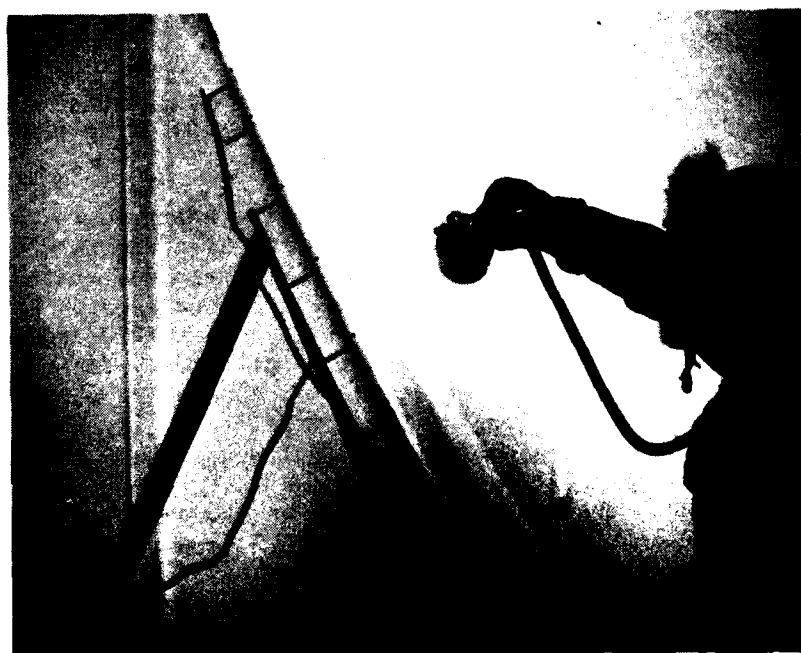
Figure 4. Icing of the panel, spray gun application of water.

A series of tests revealed that it was best to create ice using water with a temperature less than  $+2^{\circ}\text{C}$ , and a room temperature of approximately  $-6^{\circ}\text{C}$ . With a room to water temperature difference greater than  $15^{\circ}\text{C}$ , cracking and lifting of the ice occurred. This resulted in less than 100% adherence of ice to the panel. Two sprayers were used: a squirt bottle and a compressed air paint spray gun. The squirt bottle was used first to prevent the copolymer surface from being contaminated with oil from the compressor. After the surface was covered using the squirt bottle, the paint spray gun was used to build the 0.64-cm thickness (Fig. 4).
